Habitat Consult

INSPECTION REPORT

Building located at : 1234, street name
City (Province)

Inspection date : Year/month/day

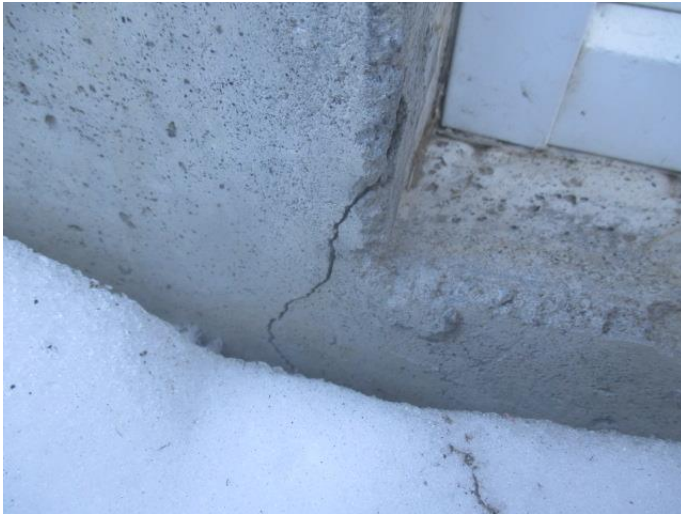
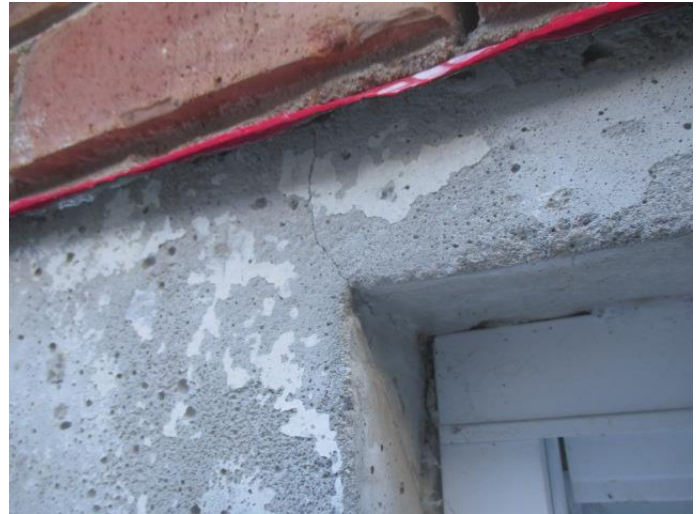
FOUNDATIONS (CRACKS)

There are some minor cracks on the foundation wall around the basement windows on the left side of the building. Furthermore, there are some steel ties to remove and seal from the concrete near the ground level in the same area. It could have occurred following the evaporation of water in the concrete and(or) the settlement of the ground, Despite the absence of problems, we recommend to monitor these cracks to assess whether they expand in time and recommend repairs eventually as prevention. The foundation walls being insulated with rigid boards makes it less likely to lead to moisture issues on the finishing. Usually, cracks could be repaired by digging out the soil in order to proceed to a urethane/epoxy injection and the installation of a membrane for an efficient drainage.

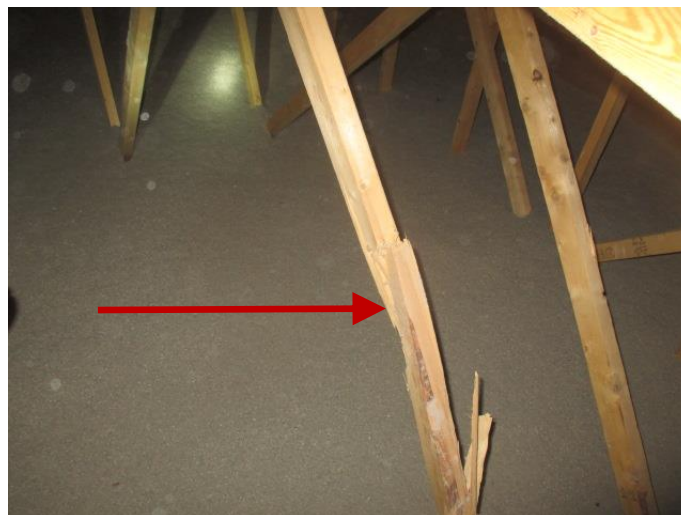
ROOF (TRUSS)

The roof truss is damaged in the upper attic at the front where some component (2x4) needs to be reinforced on the structural web to prevent sagging.

Damaged component on the roof truss

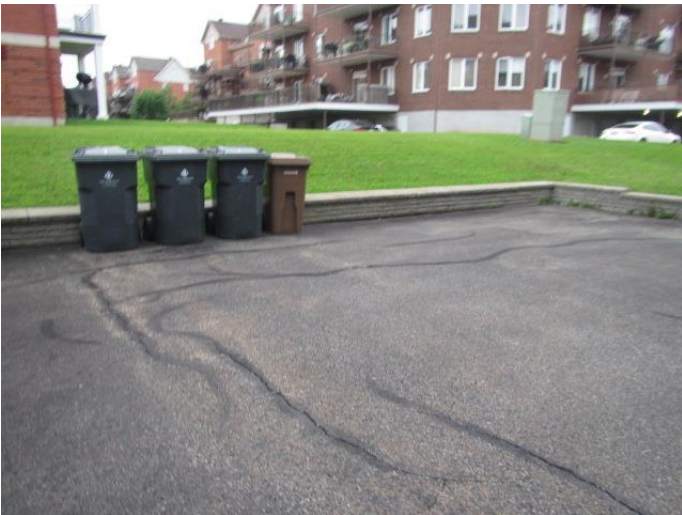
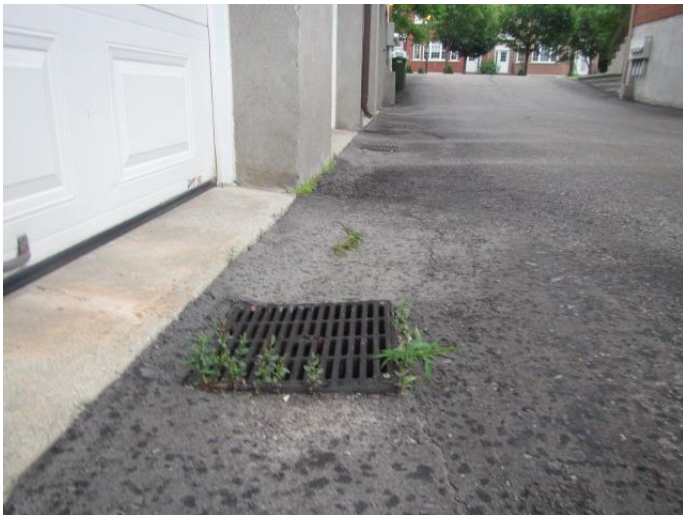
The asphalt pavement in the driveway shows signs of aging such as cracks and sagging around the drains in front of the garage doors. It is recommend to seal the cracks and seal the pavement by applying a formulated sealer to maintain and extend the lifespan of the components and to restore the pavement around the drains to prevent further deterioration. For a more durable surface, it is advisable to use concrete or stone blocks along the garage doors to provide with a more stable surface around the drains.

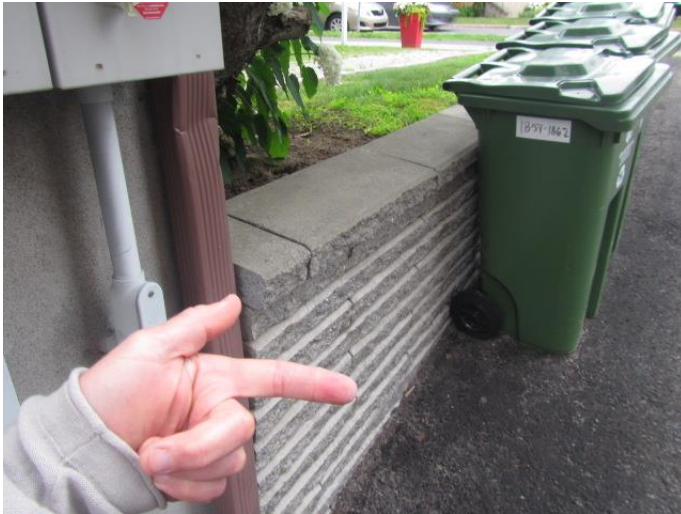
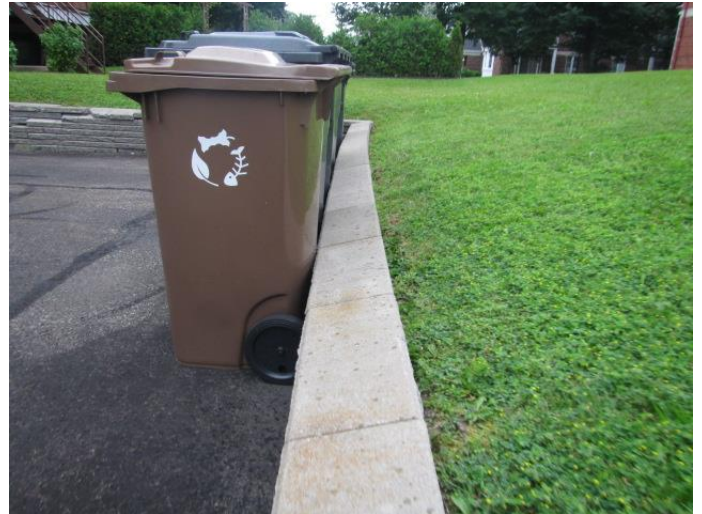
RETAINING WALLS (LEVEL)

The retaining walls along the driveway will need to be reinstalled and leveled because they are bent and twisted due to the expansion of the backfill. Ensure to backfill the walls with granular fill resistant to frost and drain the foundations with a drainage pipe to reduce underground water pressure.

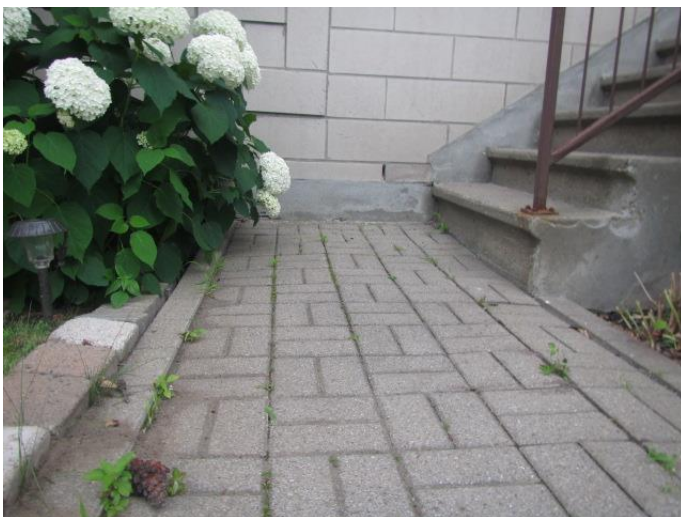
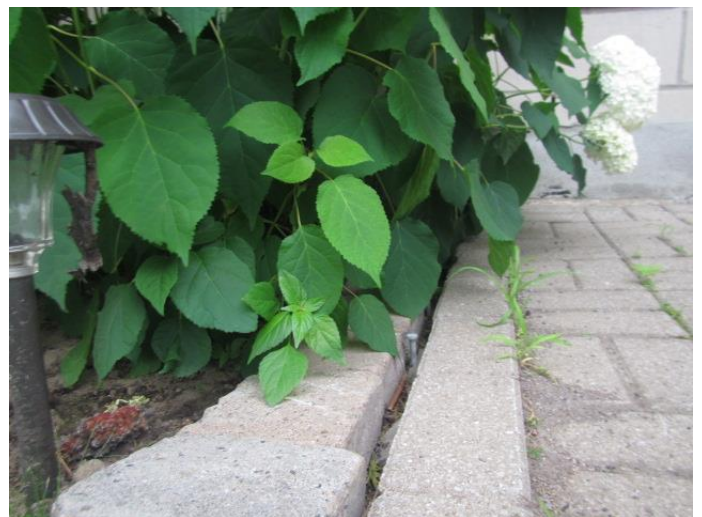
WALK (SAGGING)

The front walk shows sagging on the ground due to the shrinking of the granular fill since the construction. Plan to restore the stone blocks on granular fill properly compacted and leveled to ensure an efficient drainage and to reduce the height at the stair junction that should not exceed 8'' (200mm) for safety reasons.

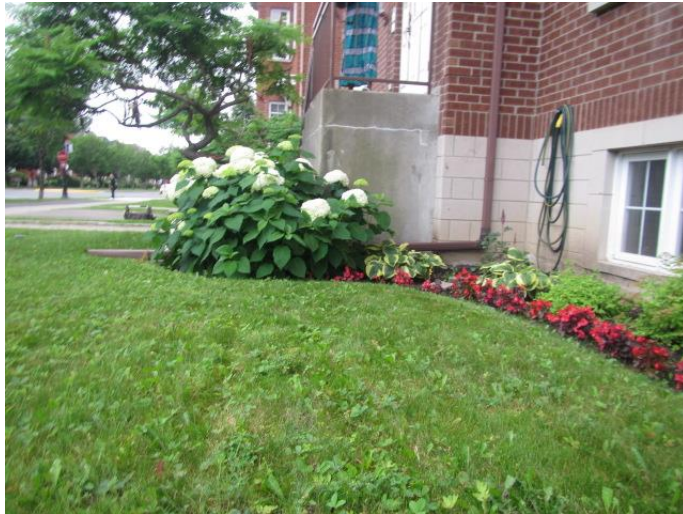
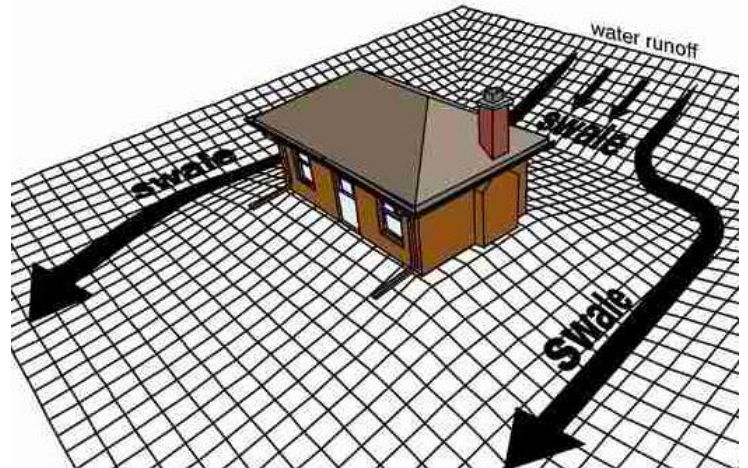
DRAINAGE (LAND SLOPE)

The landfill shrank down along the perimeter of the building since the construction resulting in the slopes not being properly leveled which could cause excessive drainage of rain water onto the foundations. For instance, this condition was observed at the front and around the drains in front of the garage doors. It occurs often due to the natural compaction of the backfill a few years following the construction and could lead to water penetration and (or) moisture into the basement. For these reasons, the land slope should be properly leveled where needed while redoing the landscaping.

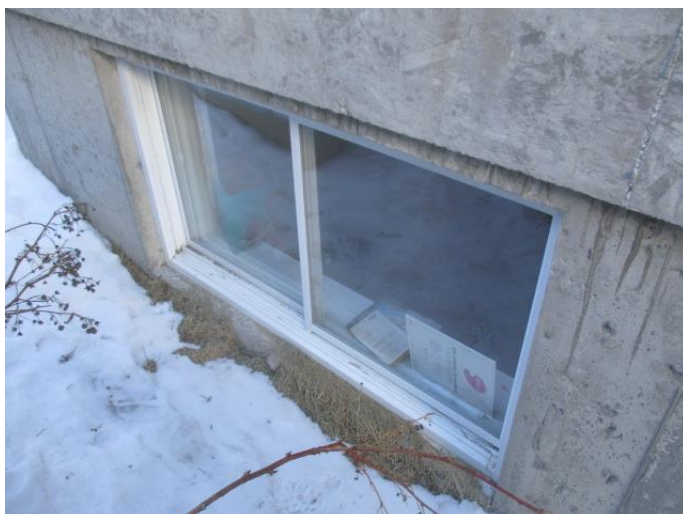
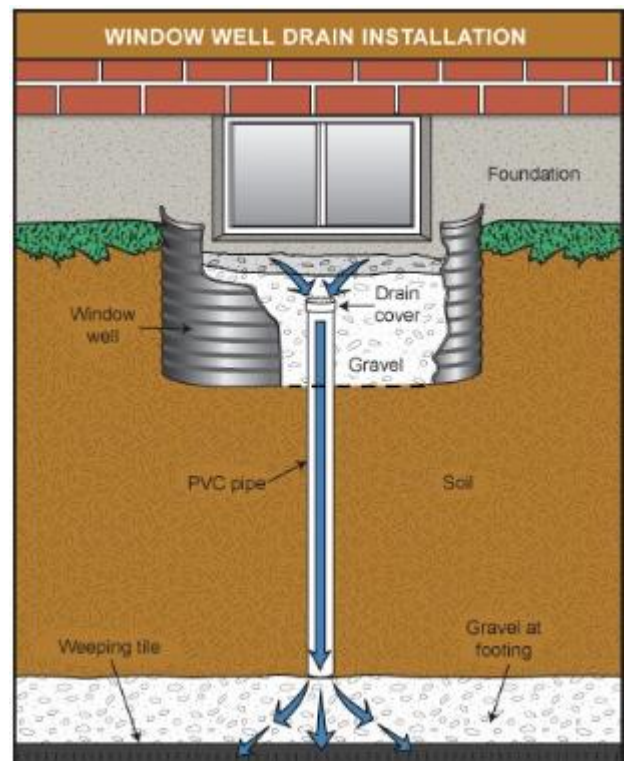
LANDSCAPING (WINDOW)

We recommend installing a window wells around the basement bedroom on the left side which could be made of metal or retaining walls made of stone blocks as prevention. The clearance between the grade level and the bottom of the window frames should be of at least 8'' (200 mm) to prevent water infiltrations through the junctions.

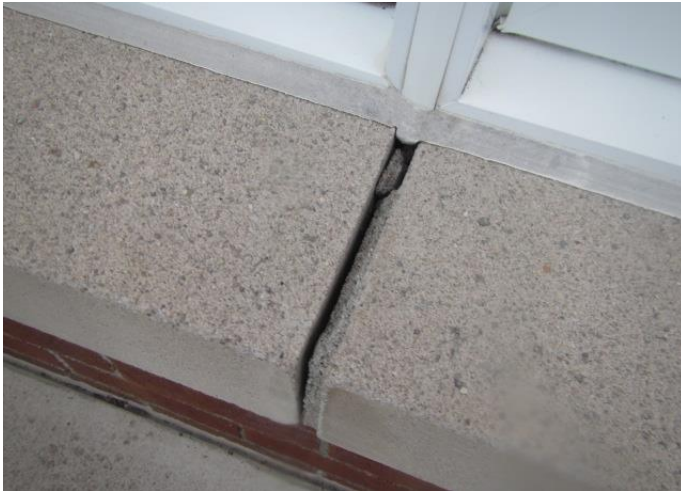
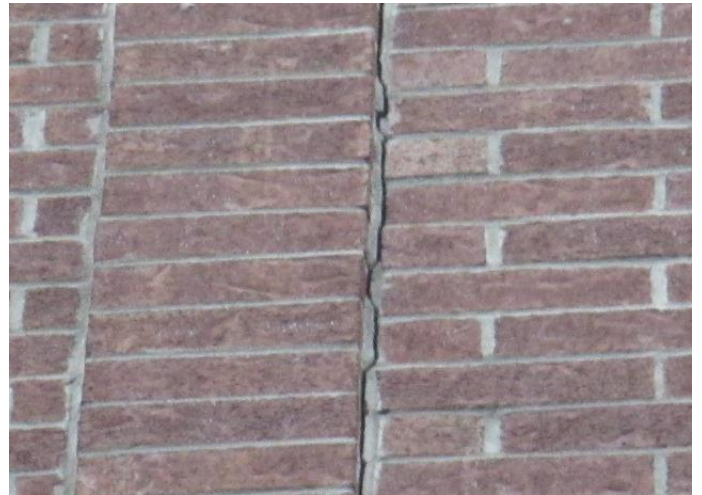
The mortar joints are damaged in some scattered areas sur as between the sills under the windows and along the vertical expansion joint on the left side. Repair the mortar joints where needed to prevent water leaks, damage and moisture beneath the exterior walls. For a longer lasting result, the junctions between the sills could be filled with caulking made of urethane. It is important to maintain the caulking in good condition because water leaking problems or insect invasions result most often from damaged joints.

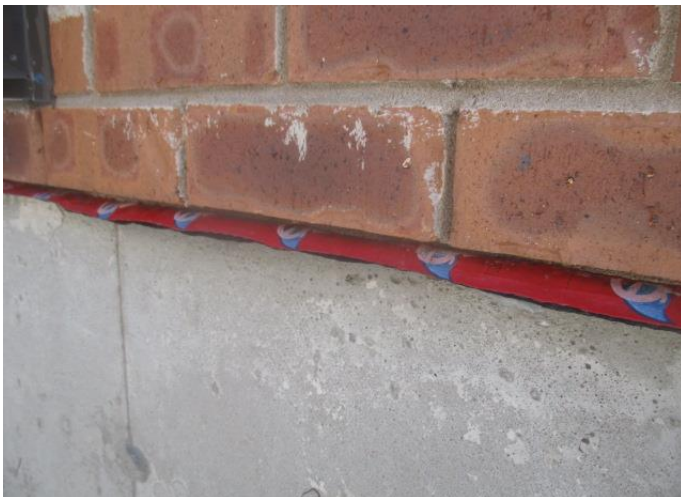
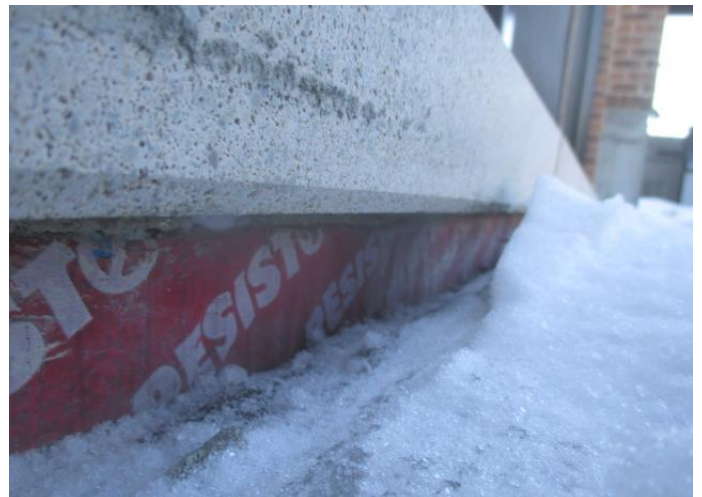
MASONRY (FLASHING MEMBRANE)

The flashing membrane should be trimmed off leaving at least 5mm upon the completion of the cement parging on the foundation walls.

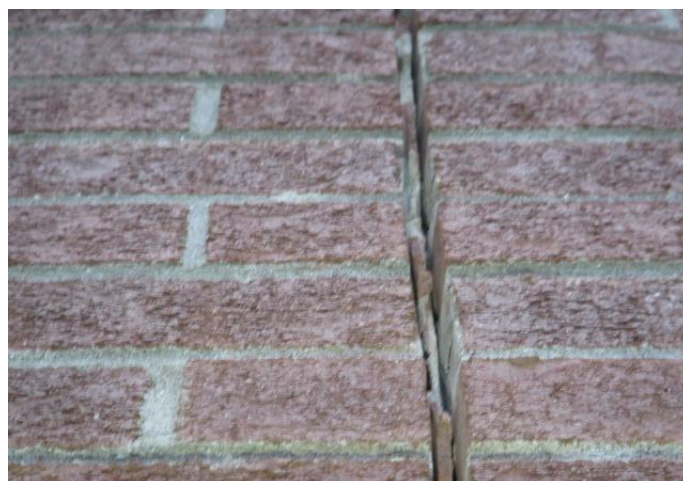
MASONRY (EXPANSION JOINTS)

The expansion joints were grooved into the bricks most likely after the construction at the junctions probably due to an omission by the builder but they should be caulked to prevent water penetration through the components and for a better finish.

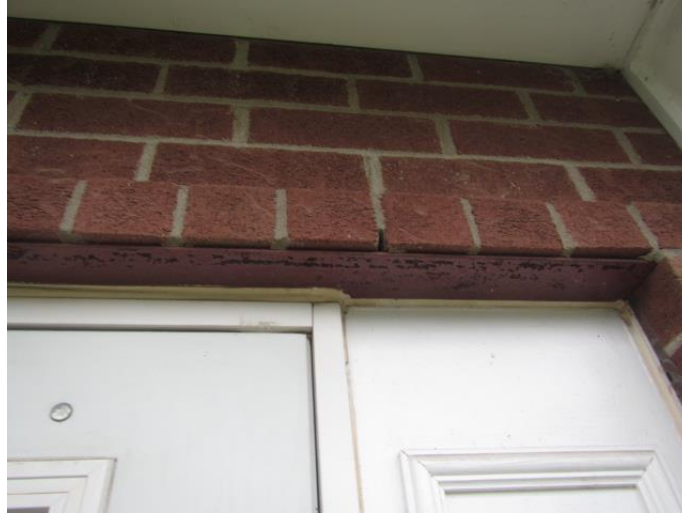
MASONRY (STEEL ANGLES)

The steel angles above the openings require maintenance to prevent deterioration due to corrosion on the components. Steel components need sanding and repainting on a regular basis approximately every 5 years to maintain them in good condition as oxidation builds up in time.

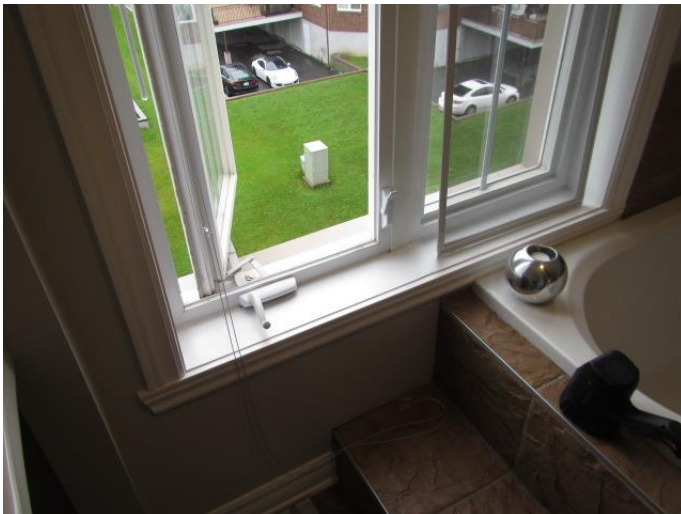
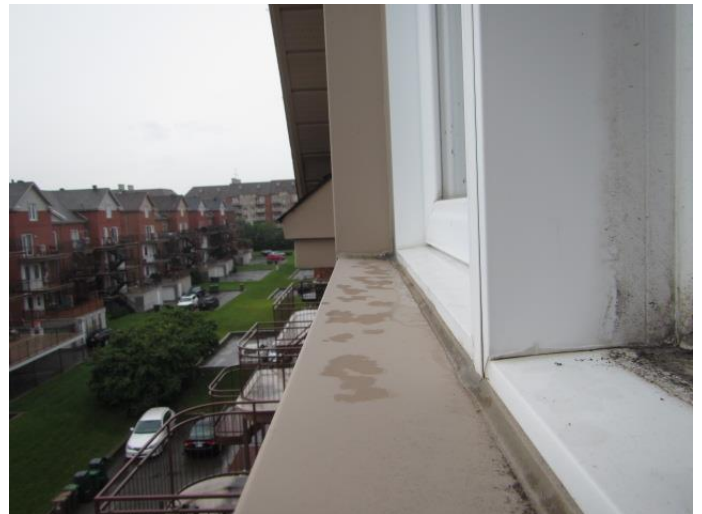
SIDING (BATHROOM WINDOW)

The frame finish made of aluminum should be adjusted along the window sill in the bathroom of the master bedroom to provide an efficient drainage and prevent risks of water infiltration through the junction.

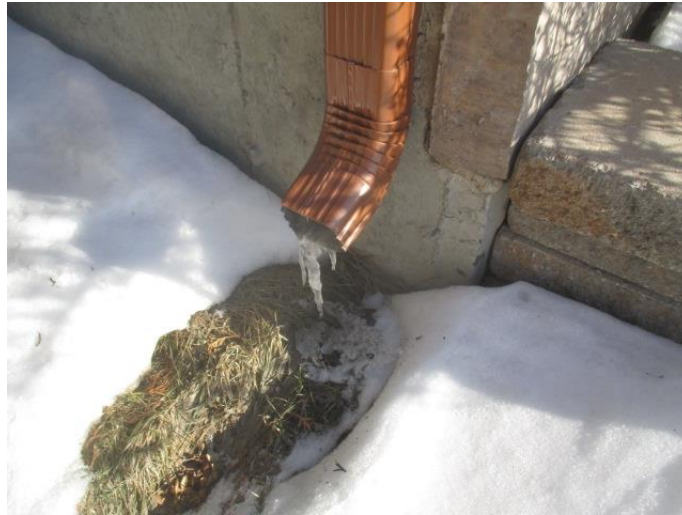
GUTTERS (DRAINAGE NEAR OF THE BUILDING)

The downspouts connected to the gutters drain the water near the building. We recommend to extend the downspouts farther away from the building above the ground with a minimal distance of 6 feet or connect them to drainage pipes underground farther away to reduce the quantity of water to the foundations and(or) excess moisture in the basement. The use of heating cables in the downspouts could also prevent damage due to ice formation in winter during freezing and thawing cycles.

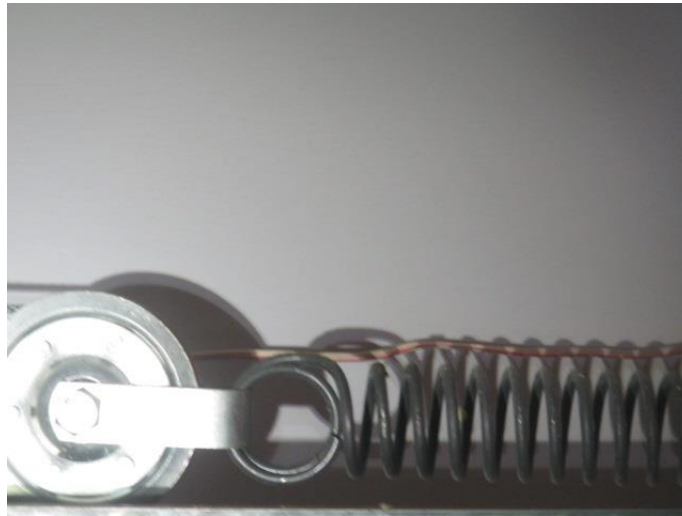
GARAGE DOOR (CABLES ON EXTENSION SPRINGS)

There should be cables installed inside the extension springs and fastened to their ends to secure the garage door in case of failure.

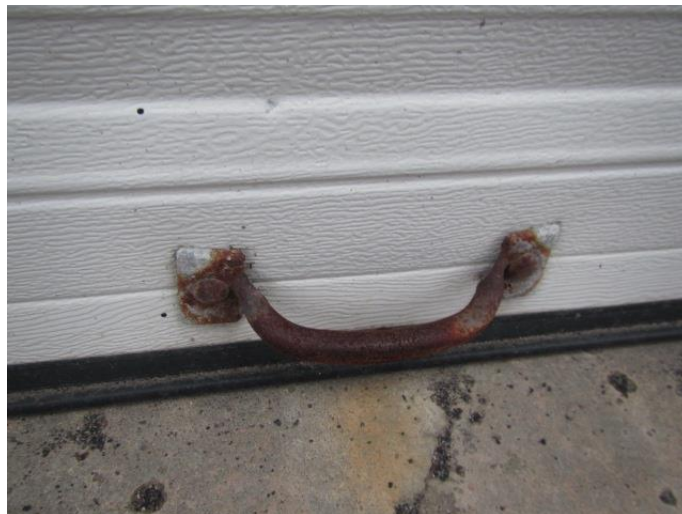
GARAGE DOOR (HANDLES)

Replace or repaint the door handles that are affected by rust.

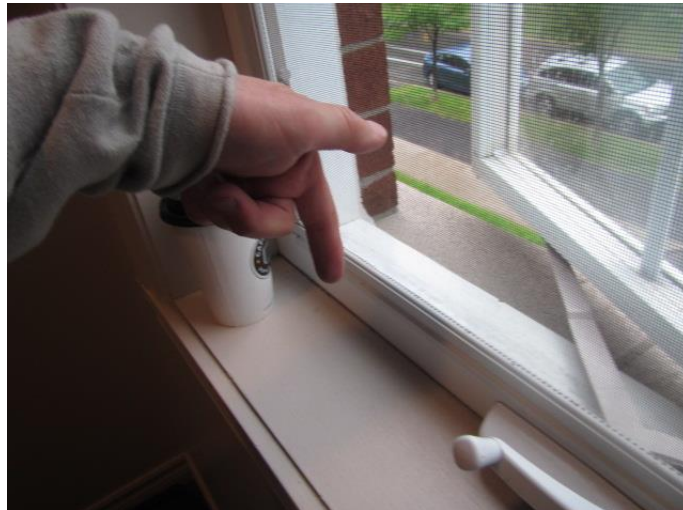
WINDOWS (ADJUSTMENT)

The windows need some adjustments in the frames to allow their opening free of obstruction due to the shrinkage of the structural components since the original construction. For instance, we observed this condition more particularly in the stair case of the common parts and less considerably elsewhere in the condo unit.

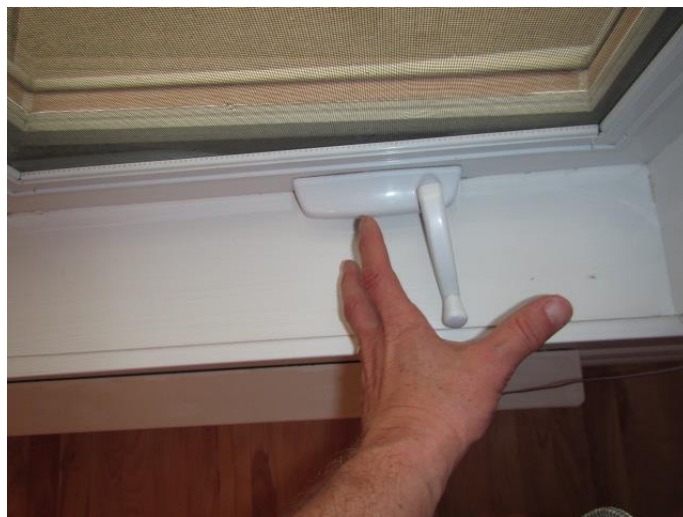
WINDOWS (CRANK)

We have observed that the crank is damaged and needs to be replaced on the window located in the bedroom/office room on the first level.

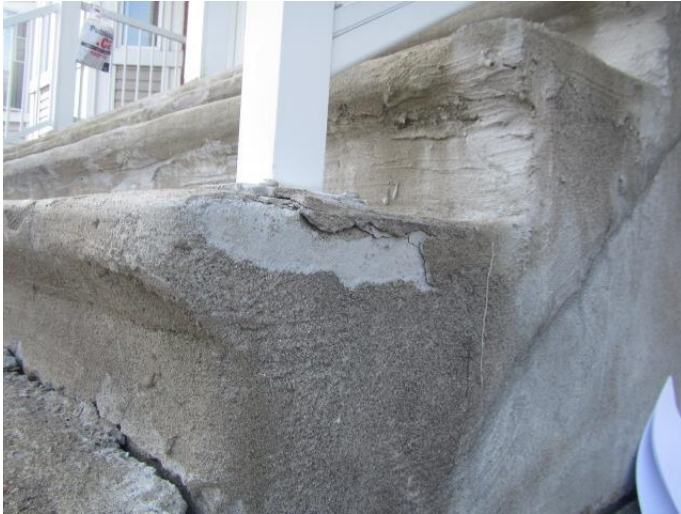
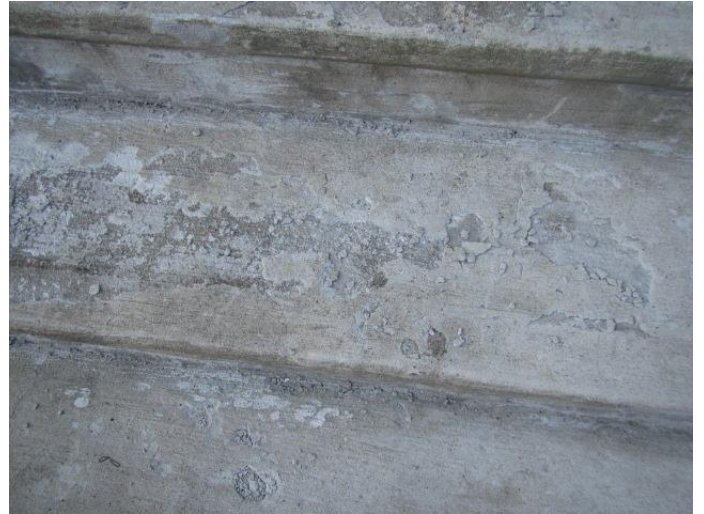
The concrete surface shows wearing on the porch usually resulting from aging combined with the use of chemical ice melt products during winter. Ensure making a proper usage of chemical products to prevent deterioration and lengthen the lifespan of concrete. For a better and more durable finish, the concrete surface could be restored eventually by adding a coating made of polymeric acrylic finishing applied by a specialized contractor. The design along the side could be made more effective against water penetration by widening the edge and grooving a channel underneath which could be done upon the future restoration.

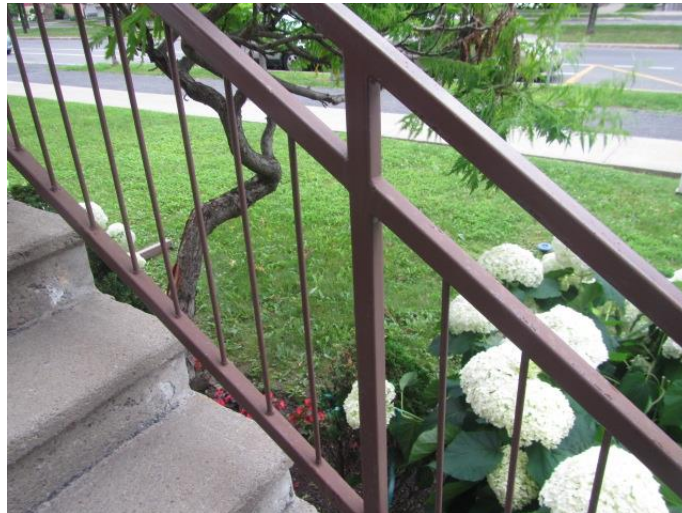
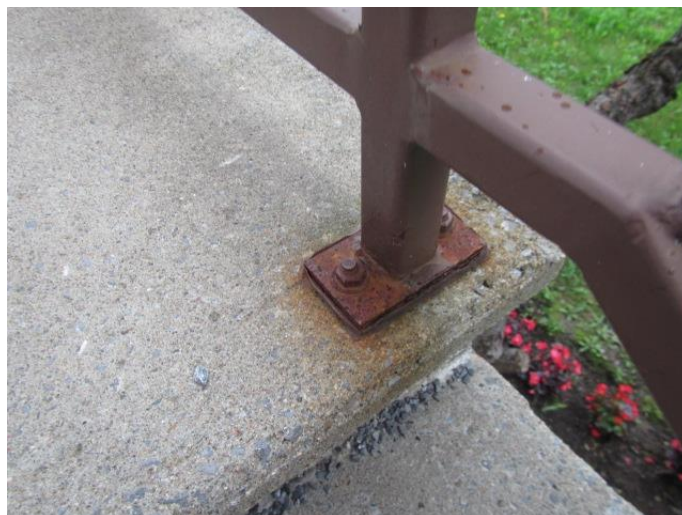
RAILINGS (STEEL)

The railings need sanding and repainting because it is somewhat affected by corrosion. The steel components require periodic maintenance and replacement of the paint approximately every 5 years to ensure their durability and staining of the other components.

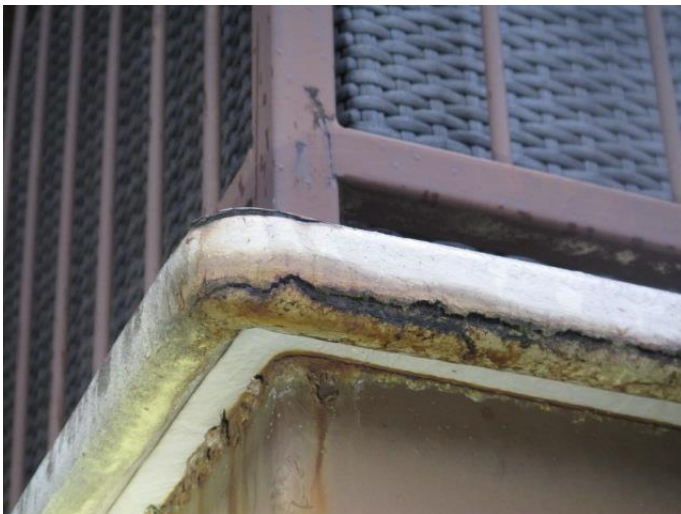
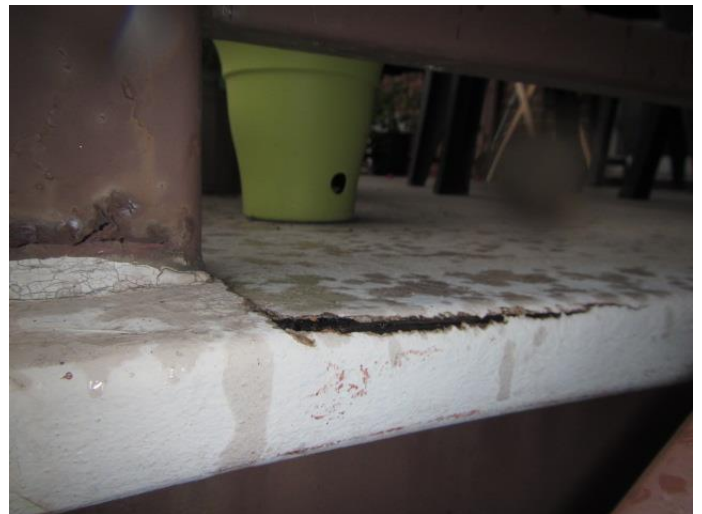
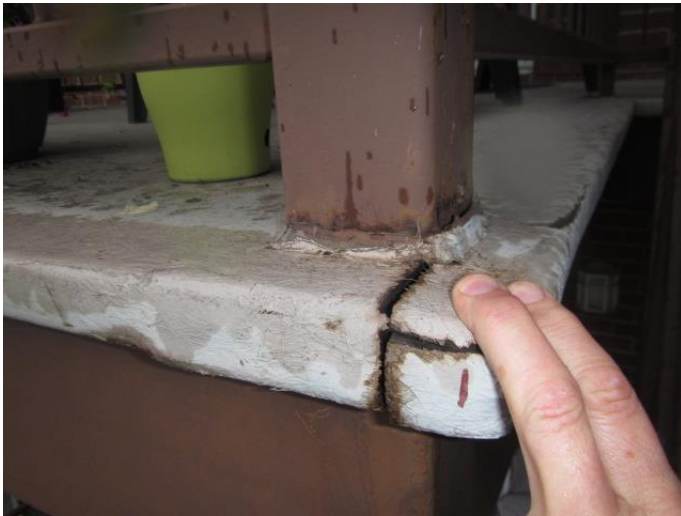
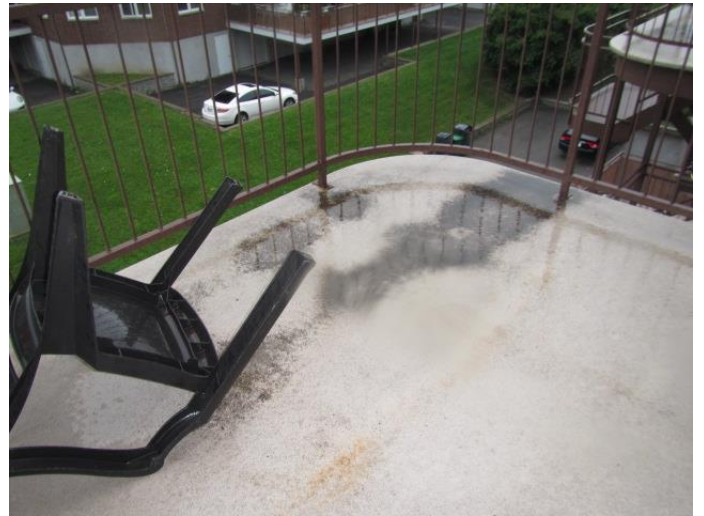
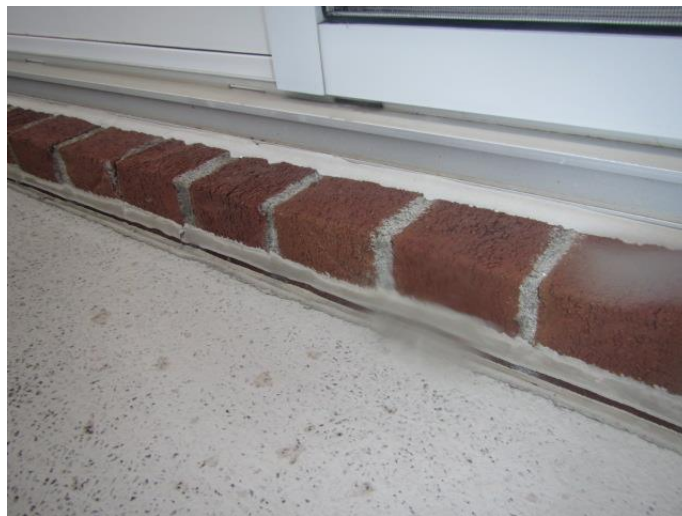
The fiberglass decks show deterioration along the edges such as around the steel columns and also the sealer and the caulking seams are wearing out. We recommend to repair the damaged parts, restore the surfaces by applying polyurethane base sealers and replace the caulking seams at the junctions in the meantime until planning a replacement of the decks.

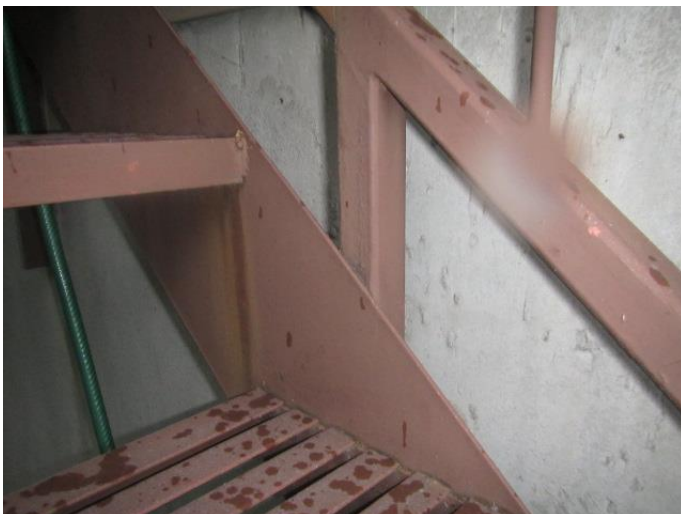
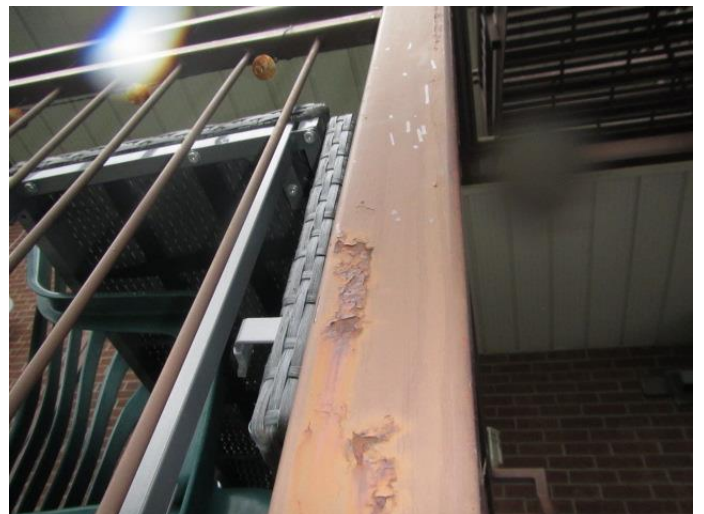
SUPPORT, RAILINGS AND STAIRS (STEEL)

The railings need sanding and repainting because it is somewhat affected by corrosion. The steel components require periodic maintenance and replacement of the paint approximately every 5 years to ensure their durability and staining of the other components.

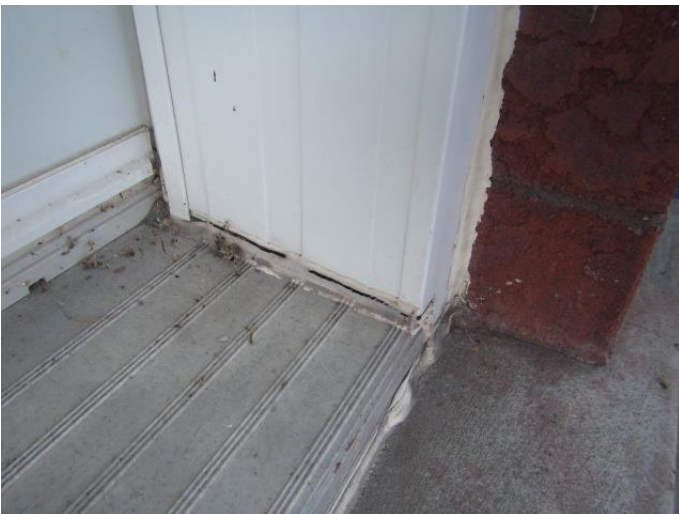
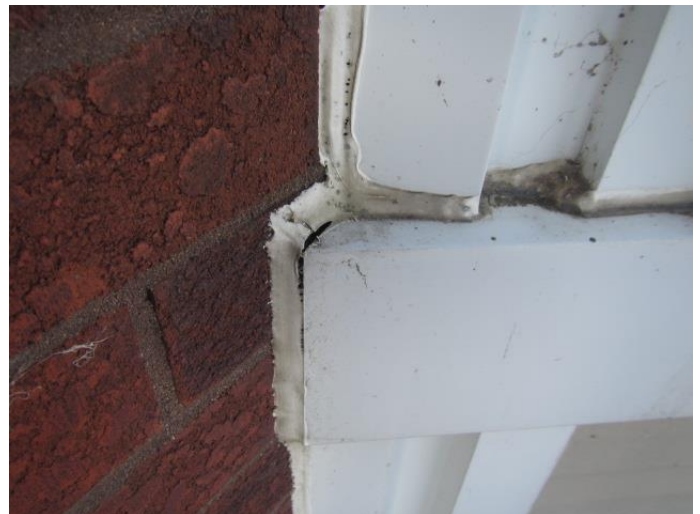
The caulking seams need replacement around the junctions such as doors, windows, balcony junctions, vent hoods, etc. because it is wearing out. The caulking around the openings and the components should always be maintained in good condition for which the lifespan ranges usually from 5 to 10 years.

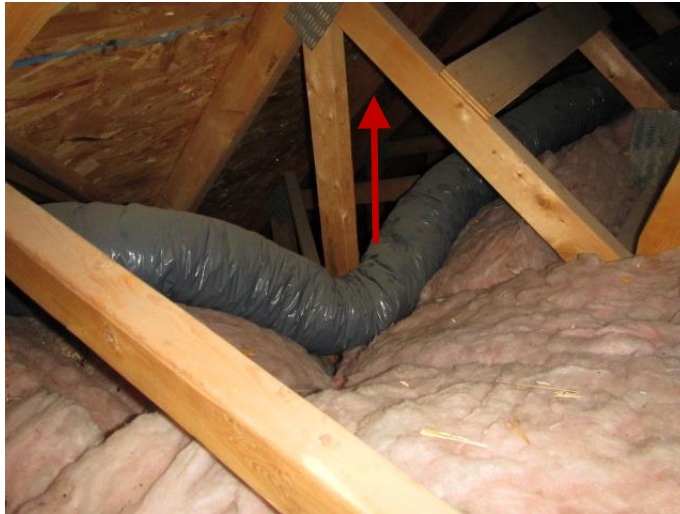
The flexible duct connected to the bathroom fan in the attic could be adjusted somewhat more upward to prevent risk of condensation in the lower loop.

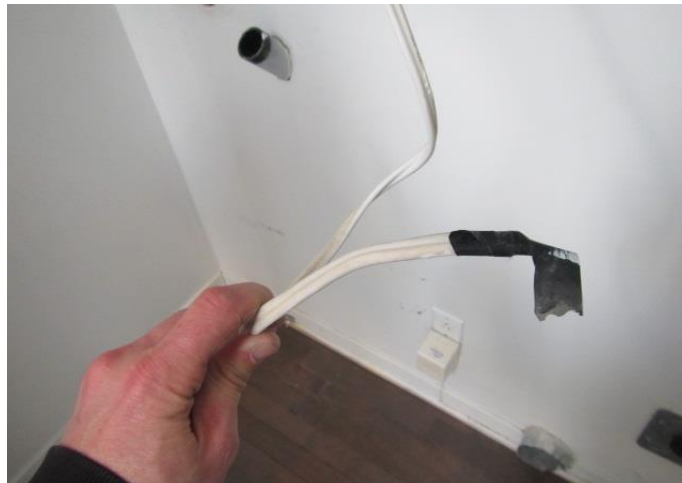
WIRING (ELECTRICAL BOXES)

Install a metal junction box and cover on the unused electrical wire in the laundry room to prevent risks of shock hazards.

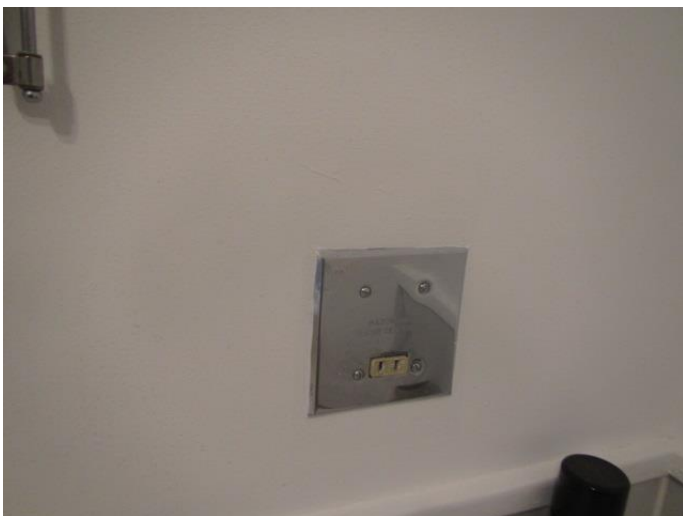
Prepare to replace the power outlet in the bathroom for the safety of the tenants. The power outlets in the bathrooms should be protected by a ground fault circuit interrupter (GFCI) and located at least 1 M (40'') from tubs or shower stalls. For safety reasons, we recommend replacing the outlet in order to prevent risks for the tenants in case of hazard.

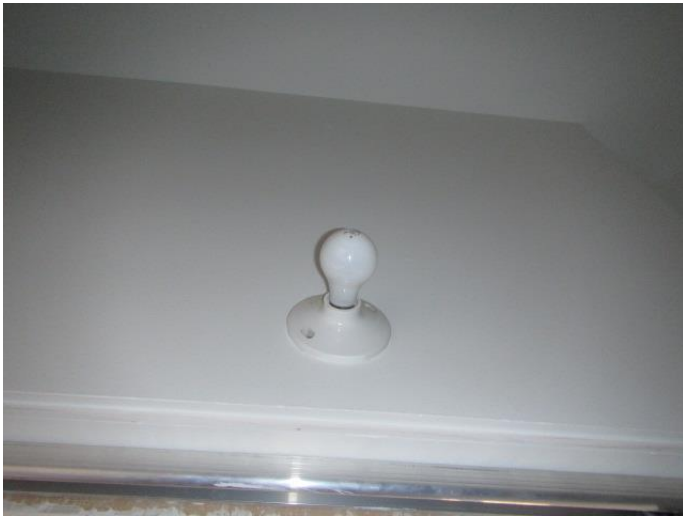
LIGHT FIXTURES (SAFETY)

The light fixture should be replaced such in the bedroom closet to protect the bulb with a cover as protection in case of contact to clothing, boxes, etc.

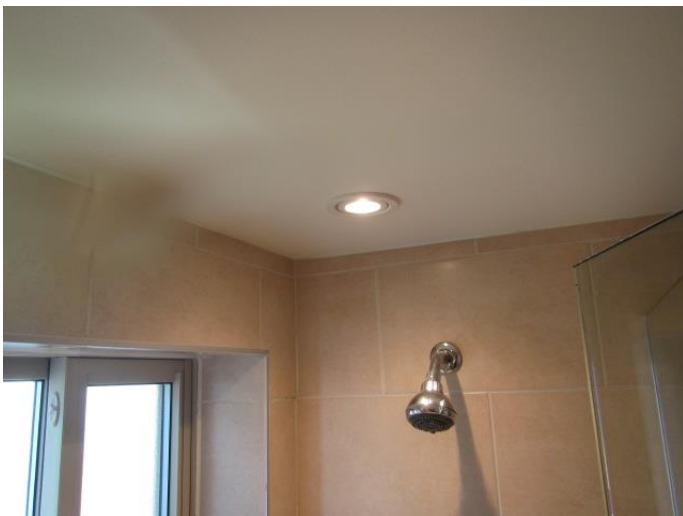
The light fixtures in the shower stall should be replaced by models designed for wet locations and protected with the ground fault circuit interrupter (GFCI) for the safety of the tenants because the ceiling clearance is less than 8 feet.

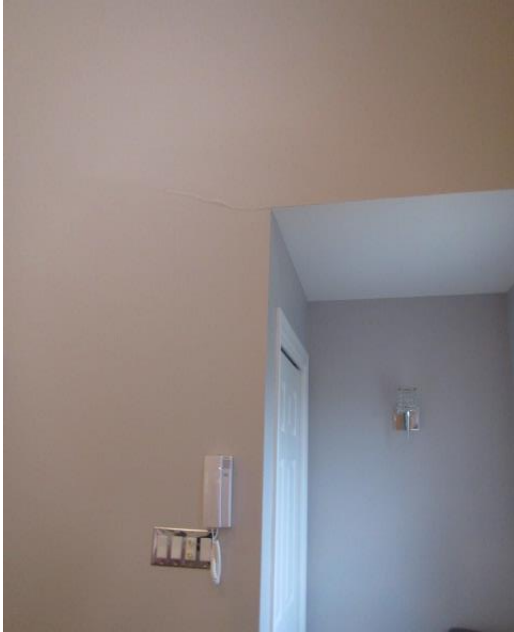
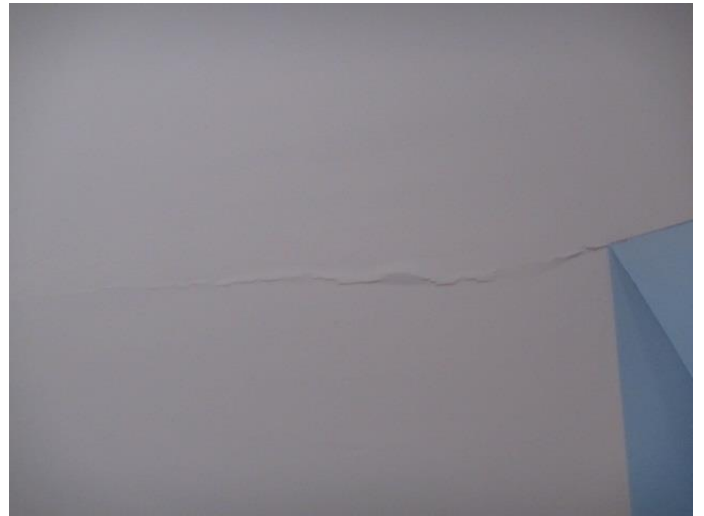
Repair the crack on the drywall in the living room near the stair which will need retaping and replastering the surface. It could result due to some causes such as stress caused by the loads on the roof (snow and wind) and(or) expansion of the structural components with the humidity level, etc.

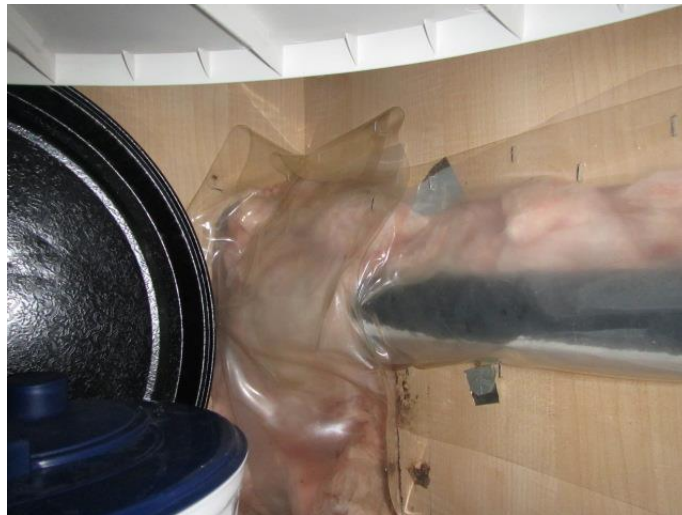
**WALLS (KITCHEN)**

The sewage pipe connected to the sink is sealed with plastic on the wall surface under the kitchen cabinet. It could mean that there is air leaks through the junction which could be corrected more efficiently instead by using polyurethane and caulking around the pipe fitting.

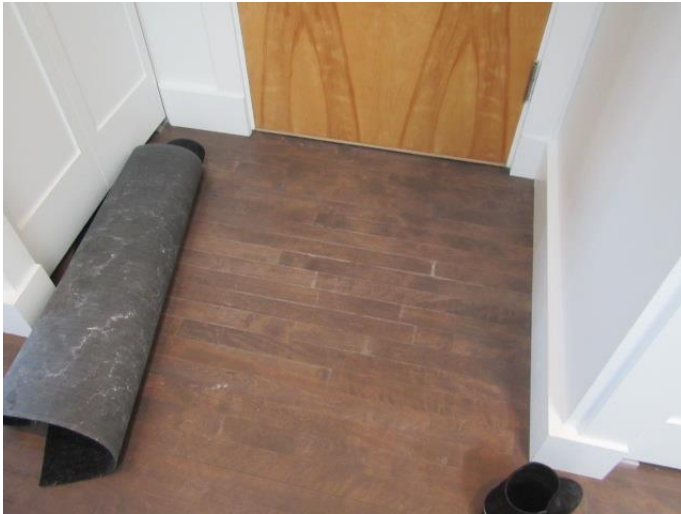
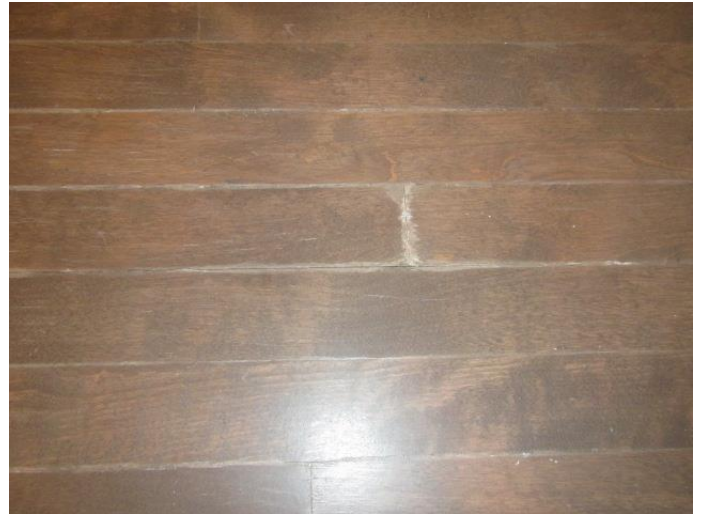
The hardwood planks shows some wearing near the entry door which could be restored eventually by sanding and varnishing the flooring.

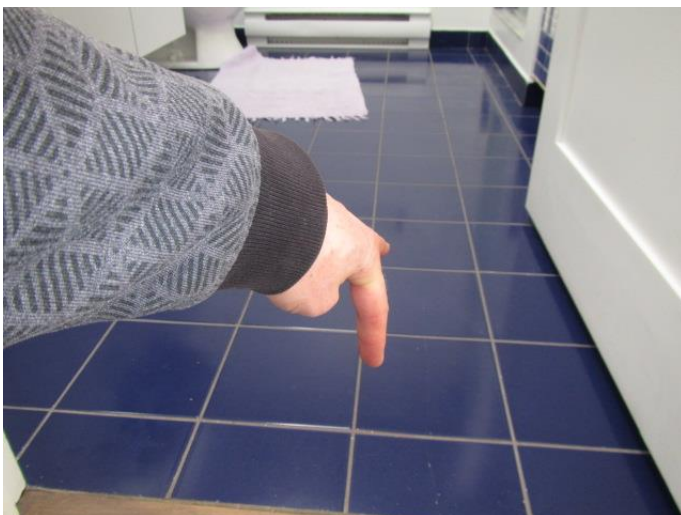
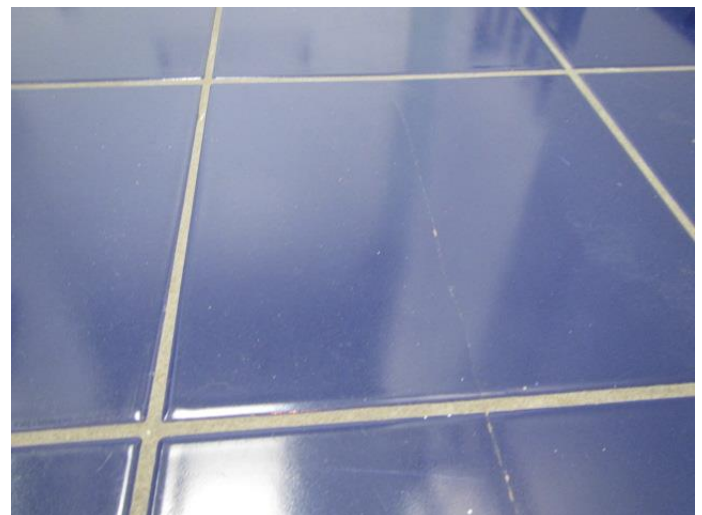
**FLOORING (CERAMIC TILES)**

We found a crack running along a straight line on the tiles in the bathroom. It usually means that the subfloor support (plywood sheet) could have moved a bit which should be fixed eventually upon the renovation.
