Habitat Consult

INSPECTION REPORT

Building located at : 1234, street name
City (Province)

Inspection date : Year/month/day

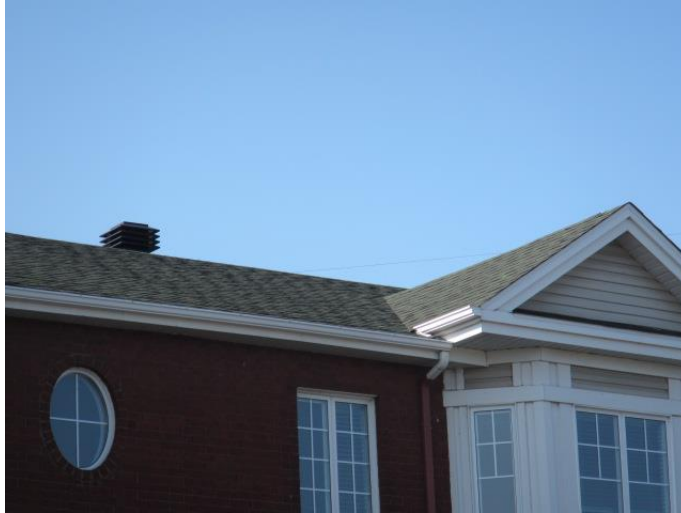
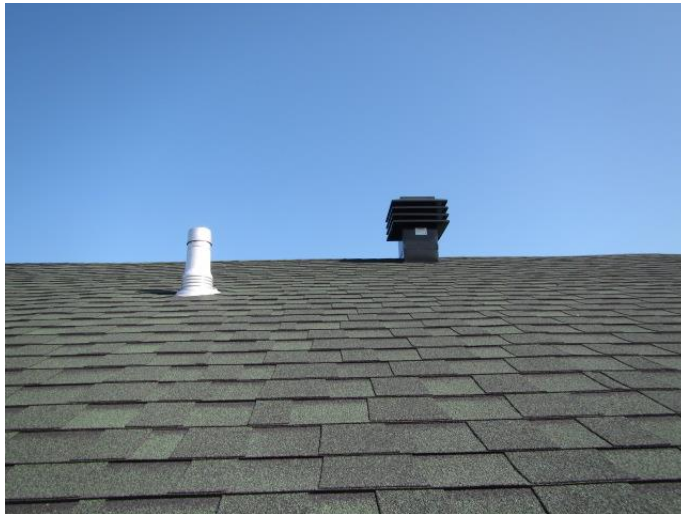
The roofing has been replaced recently of this year of 2010 according to the information provided. The usual life expectancy of asphalt shingles is about 20 to 25 years. The life span ranges upon several factors such as the weather and the quality of the shingles, the insulation and the ventilation of the attic. The caulking should be redone on a regular basis around the roof vents, plumbing vents, electrical main supply posts and so on.

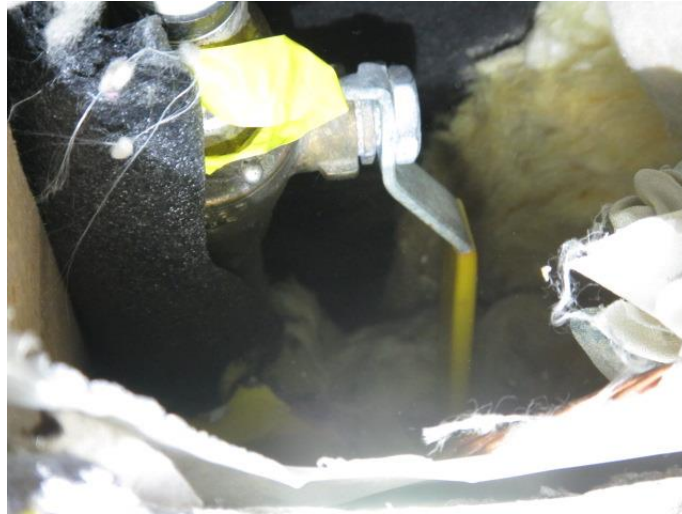
The main water faucet is not handled during the inspection as to prevent risks of leaks.

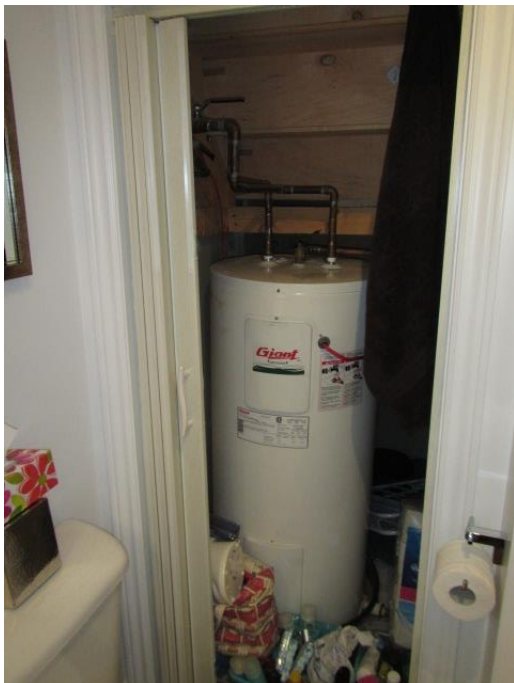
The lifespan of hot water tanks is about 12 to 15 years but most insurance companies require having it replaced upon 10 years of usage. Therefore, the replacement of hot water tanks should be planned at the frequency of 10 years to maintain the protection coverage of the insurance in case of leaks and damages to the building.

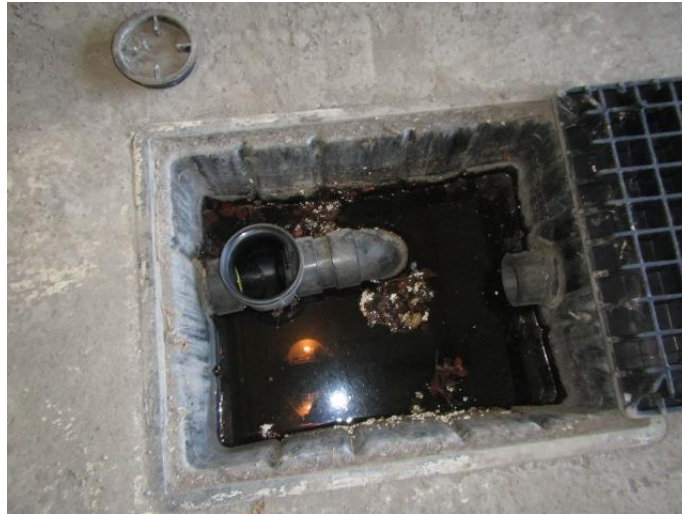
Cleaning and maintenance of the drain covers and inside the drain should be done on a regular basis to keep the drains functional because these are likely to clog in time.

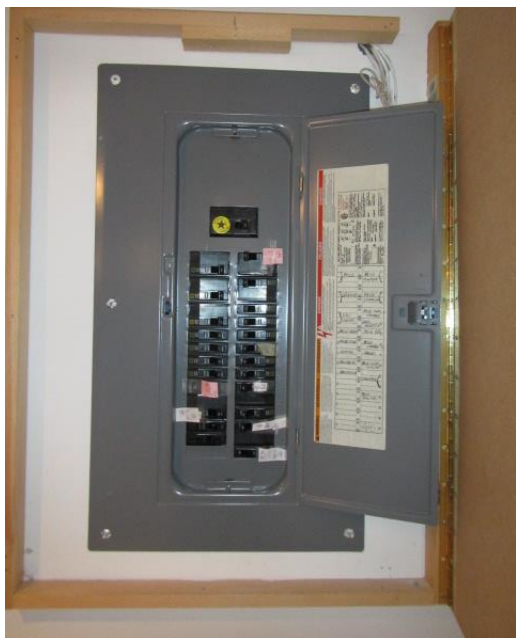
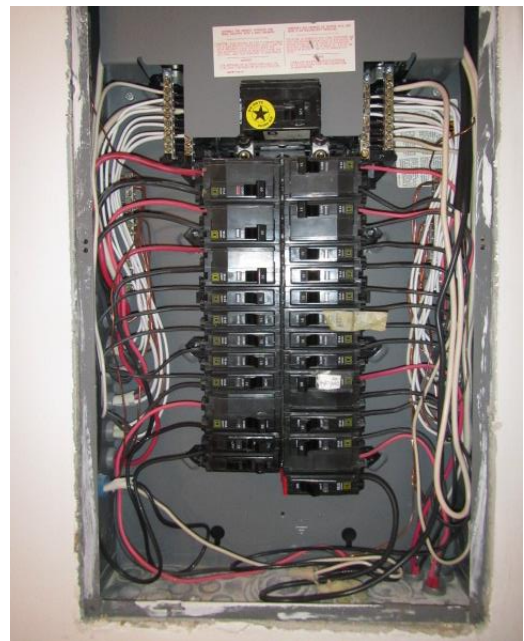
Our inspection of the electrical panel includes the components such as the panel box, the circuits and the wiring so as to assure that there are no important defects that could be a potential risks of fire in the building.

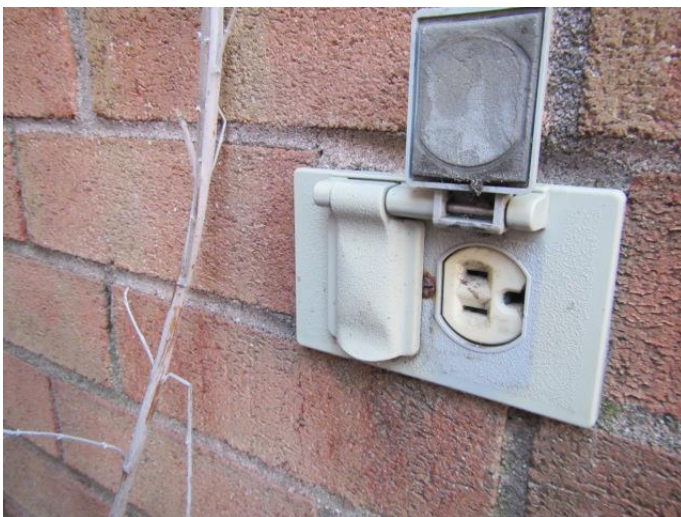
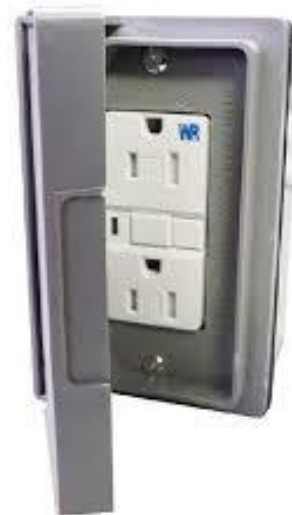
We recommend installing power outlets outside the building on the balconies for more convenience so as to prevent the tenants from using extension cords connected to the power outlets inside the units. All electrical outlets located outdoors less than 8 feet above the ground level should be protected by a ground fault circuit interrupter (GFCI) type in order to prevent injuries or death in case of hazard.

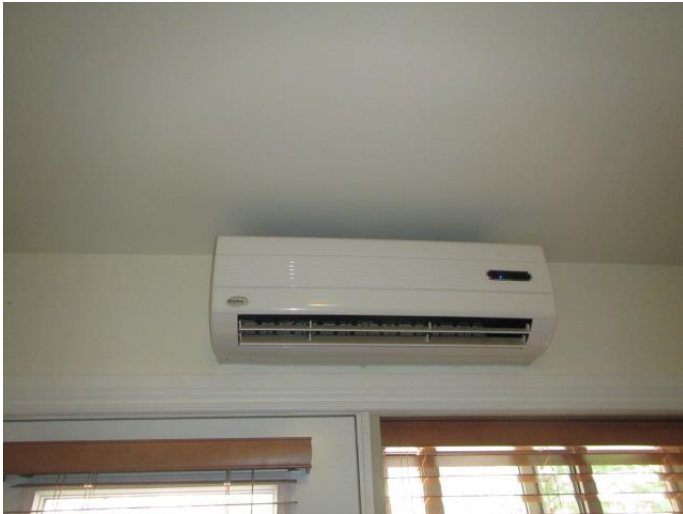
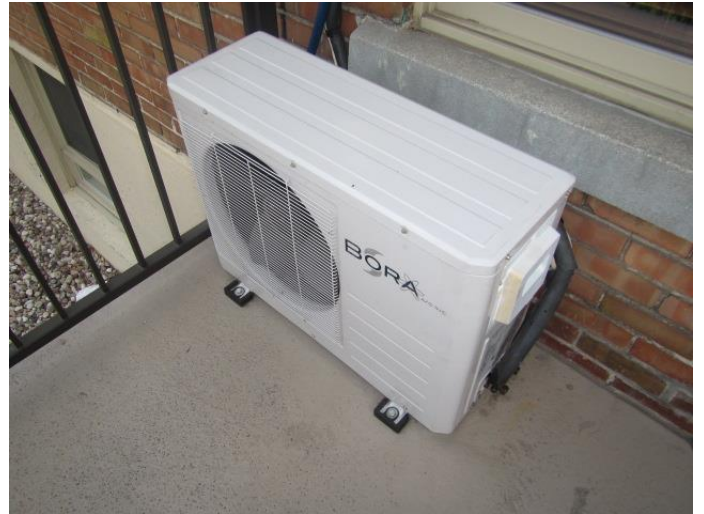
Cooling systems need cleaning of the air filters, coil and fins every month or two for the unit to function effectively and efficiently throughout its years of service. The life expectancy of such systems ranges from about 15 to 20 years. Make sure to replace the NMD wire by an NMWU wire type designed for outside locations on a single circuit and connect the condenser to a circuit breaker switch mounted on the exterior wall upon its replacement.

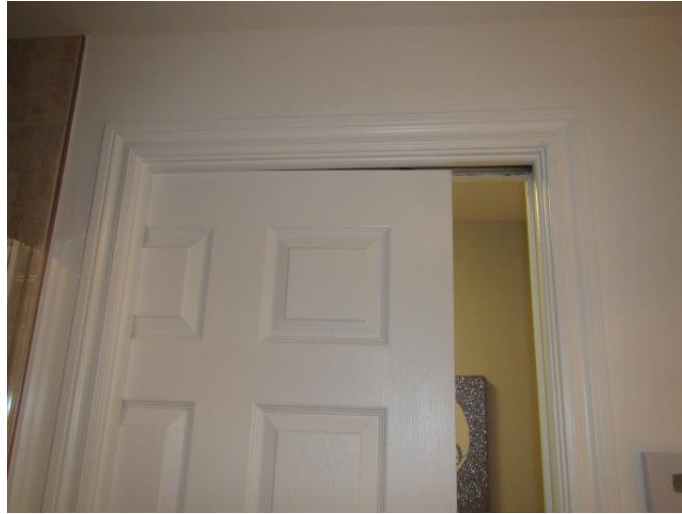
The bathroom pocket door needs to be adjusted in the partition because it gets stuck under the rail so as to allow its complete swing.
